pn Timing mode:

- what causes the brighter line?

Eckhard Kendziorra, Marcus Kirsch
01.02.2005

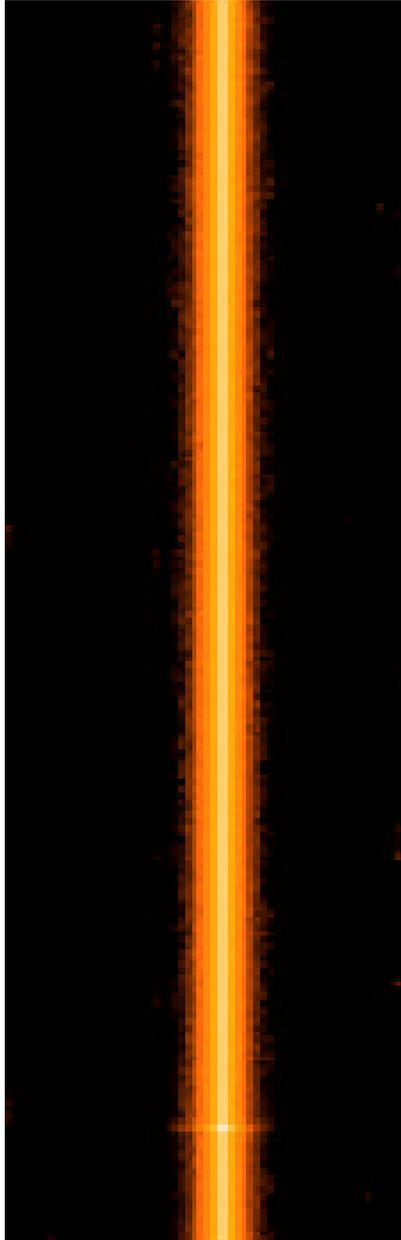
image of **point source**
in RAWX, RAWY

bright line, why?

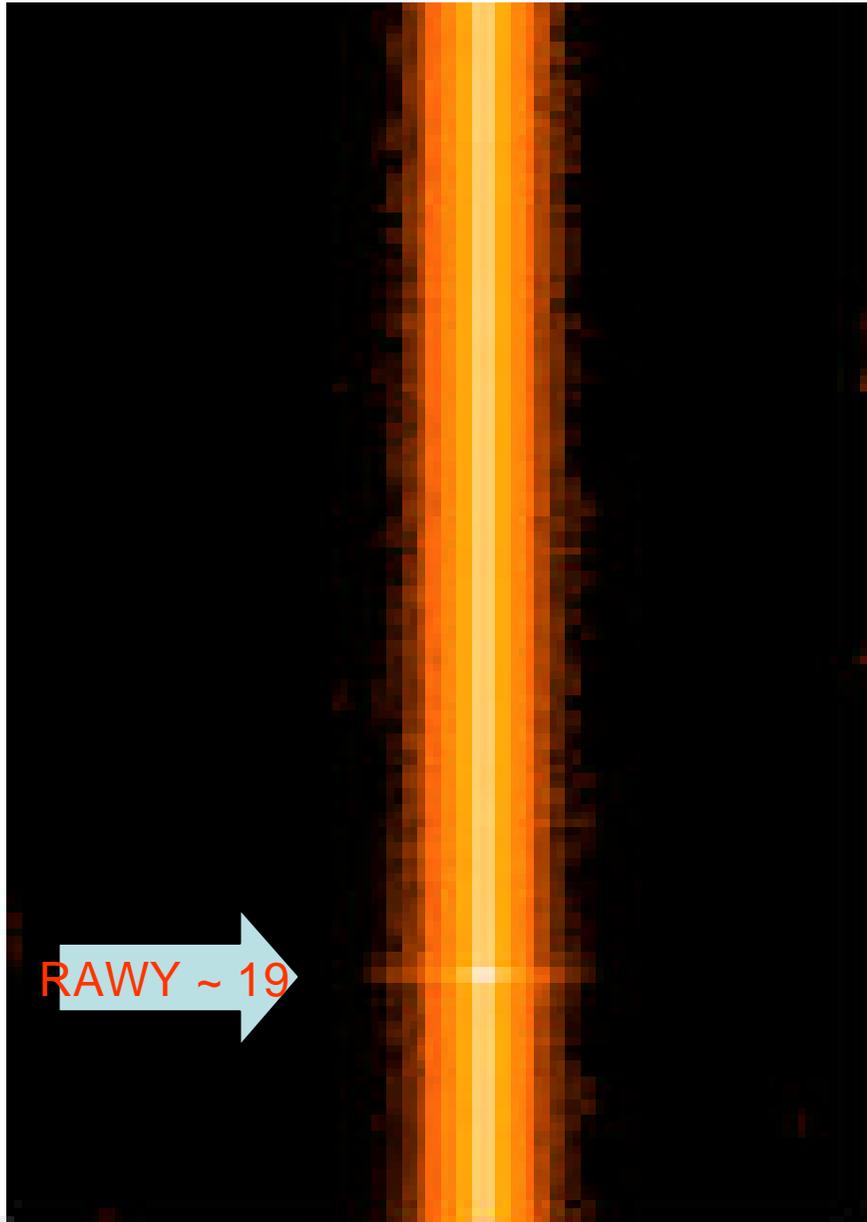
Zoom of feature

? Shows up only
for **bright point
sources**

? Problem in

- offset map? **no**
- common mode? **no**
- integration time? **yes**

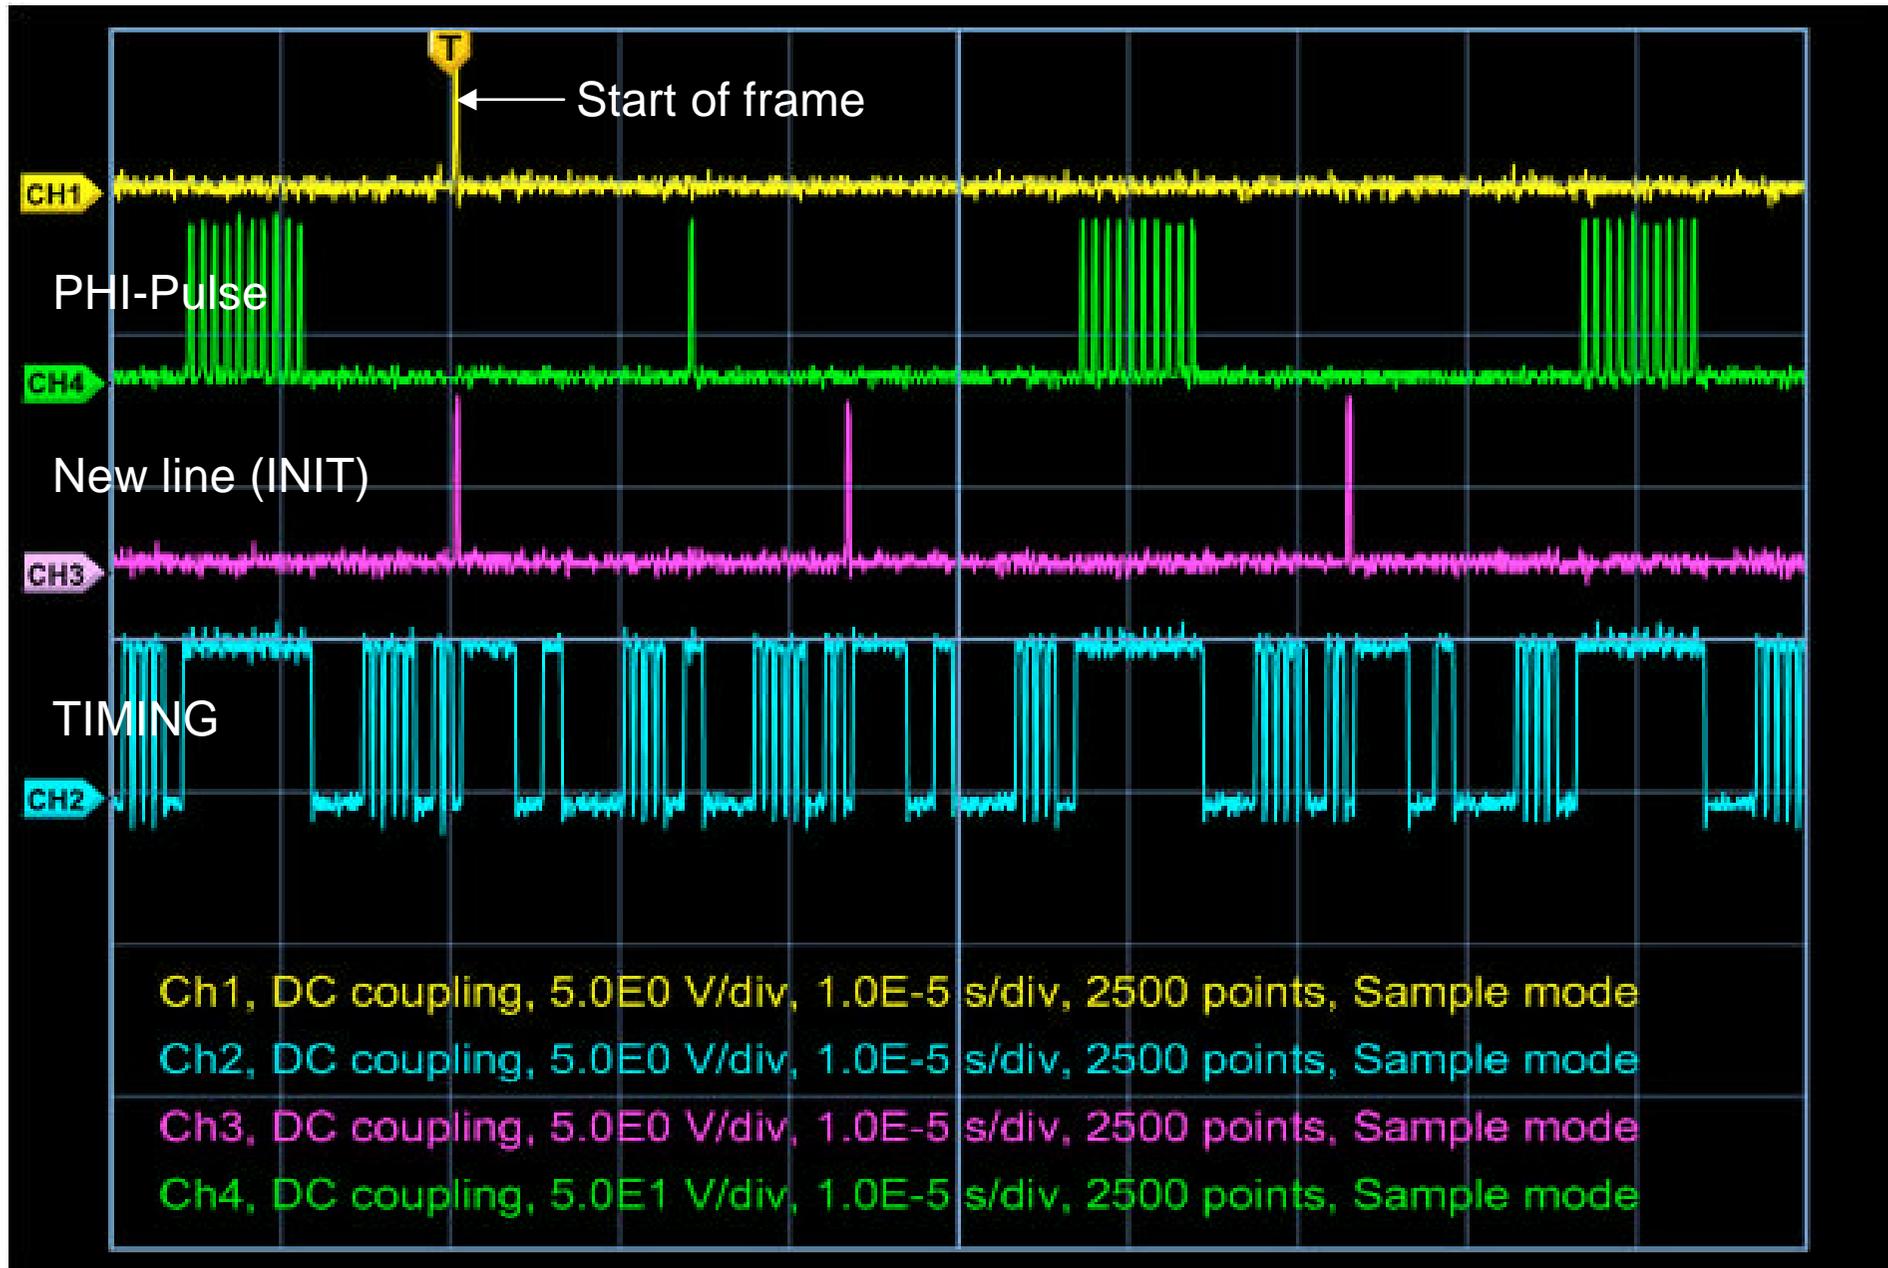
Screen shot from oscilloscope

Timing sequence measured with engineering model at IAAT

- ? QM boards of master sequencer, SECOM and CPU used
- ? on board (PROM) S/W for EPEA V5.14
 - but no changes in mode set-up since
- ? command sequence to set up Timing mode copied from flight procedures
- ? only one CCD (200 x 64 pixel)
 - same as in flight

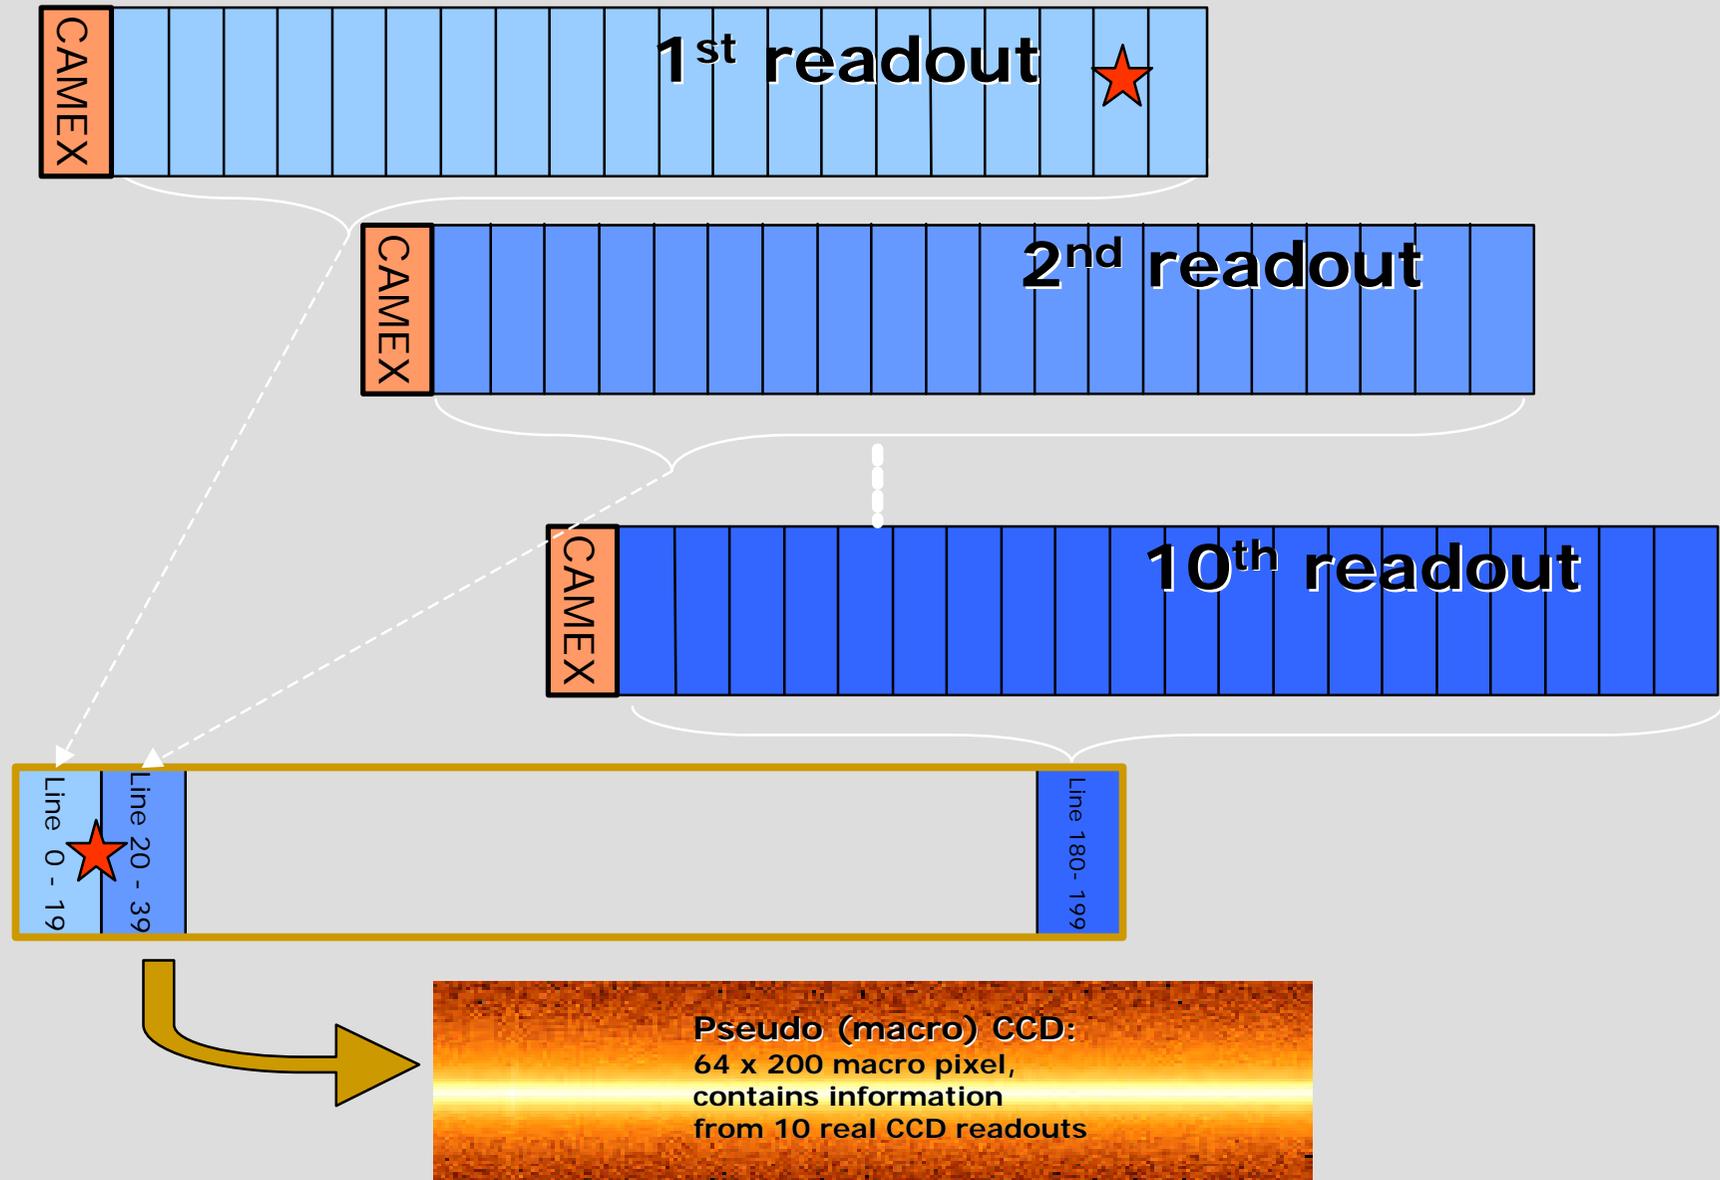
CCD readout in Timing Mode (M.K.)

Result of hiccup

? First „macroline“ contains only **ONE** CCD line,
set to **BAD** anyhow

? „Integration time“ during readout of second macroline
is **(29 + 23) μ s**

integration time for point source at RAWY = 189
is factor **1.8 longer** than for all other macrolines

macroline no. 19 gets **factor 1.8 higher flux** from
point source

Corrective actions

None,

?error cannot be corrected on board,

?no need for S/W modification on ground

- leave as is,
- mention feature in Users Hand Book
