XMM recoveries in 2008

the new operations strategy re. antennae switching

Dr. Marcus G. F. Kirsch
XMM-Newton Deputy Spacecraft Operations Manager

European Space Agency (ESA)
European Space Operations Centre (ESOC)

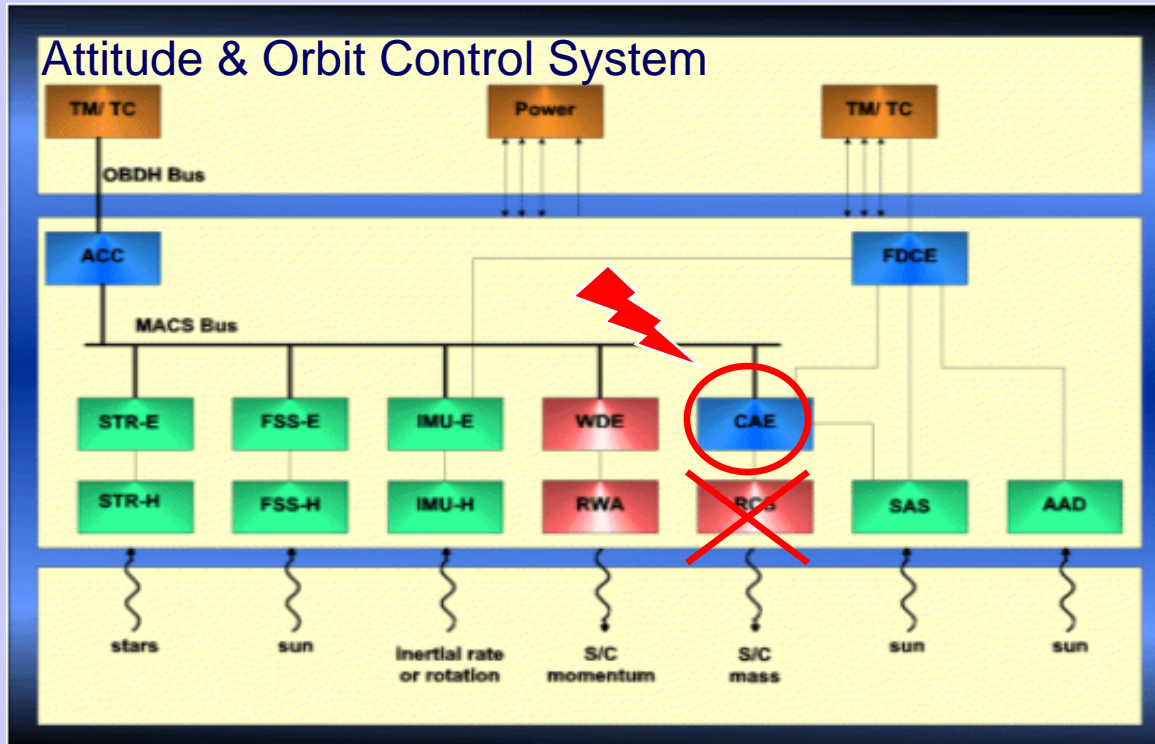
Events leading to ESAM #6

- **EVENT: LCL Trip-off CAE-A** (which drives the RCS).

- **ACTION:** CAE-A unit switched on but the Unit Configuration WORD B in the ACC was not re-initialized.

- **EFFECT:** ACC could not talk to the CAE-A → the RCS was not driven.

→ In the following Reaction Wheel Bias the thrusters didn't fire and the S/C entered in ESAM.

- LCL trip procedure corrected (CRP_AOC_4019)

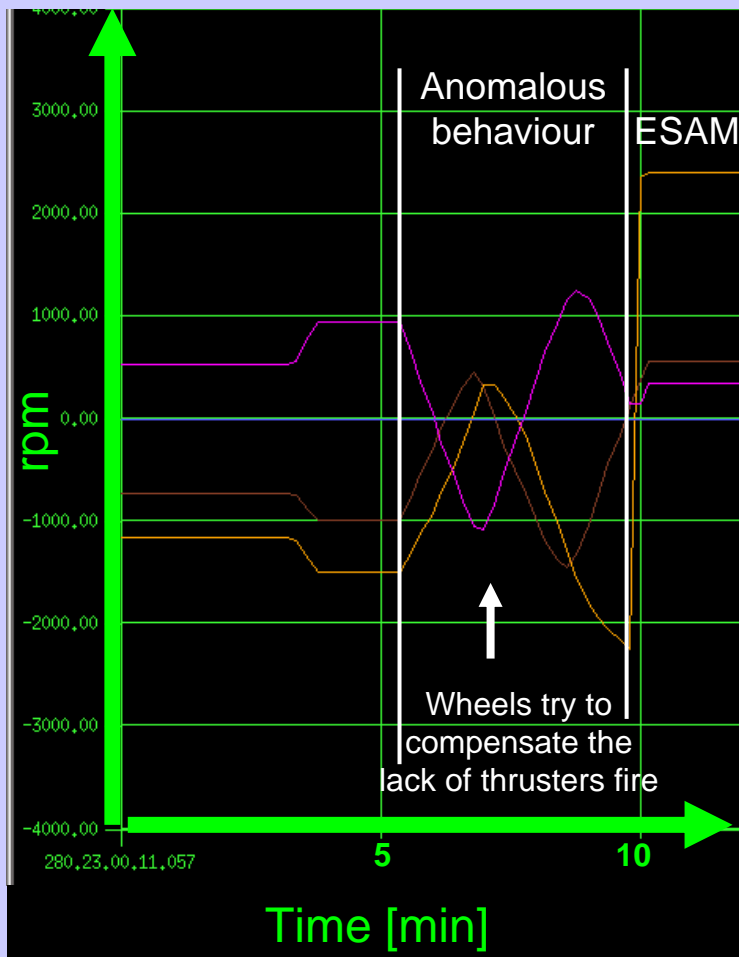
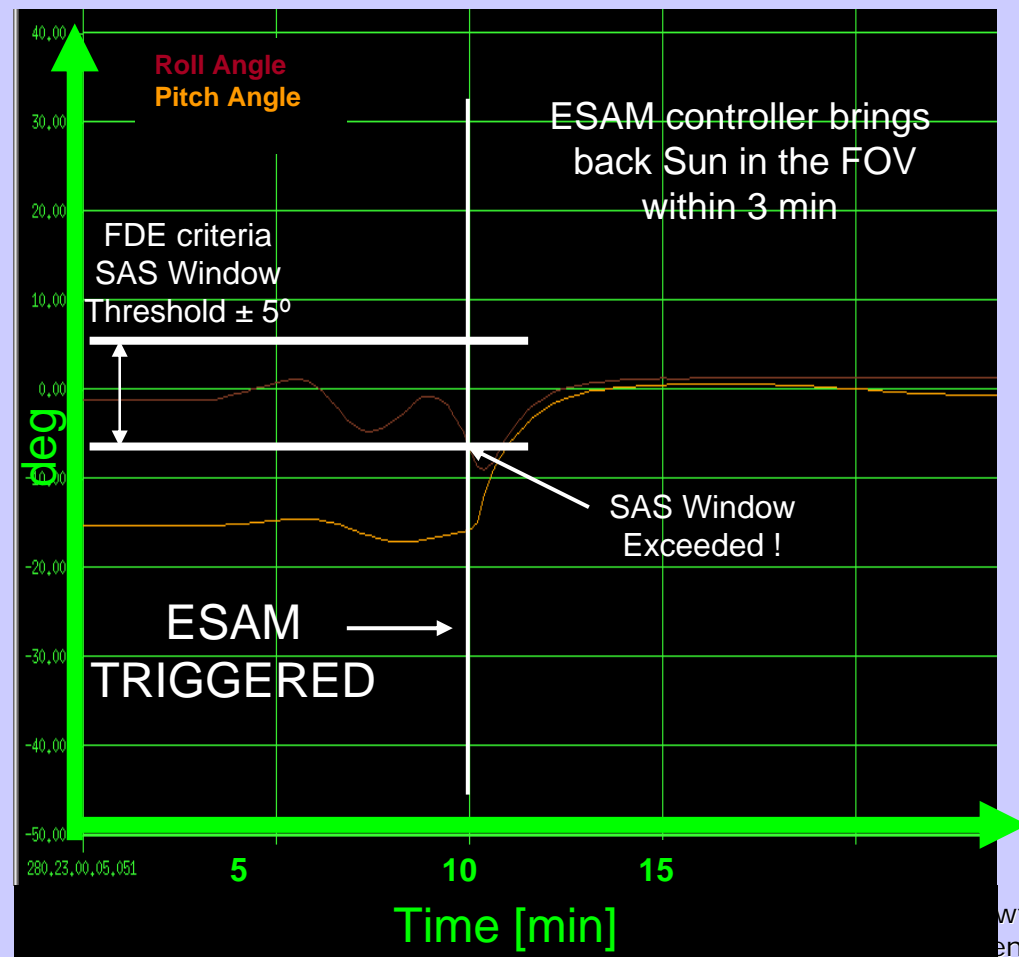
ESAM #6: entry

- wheels try to compensate the lack of thruster firing
- Roll angle hits -5 deg threshold in SAS window → ESAM

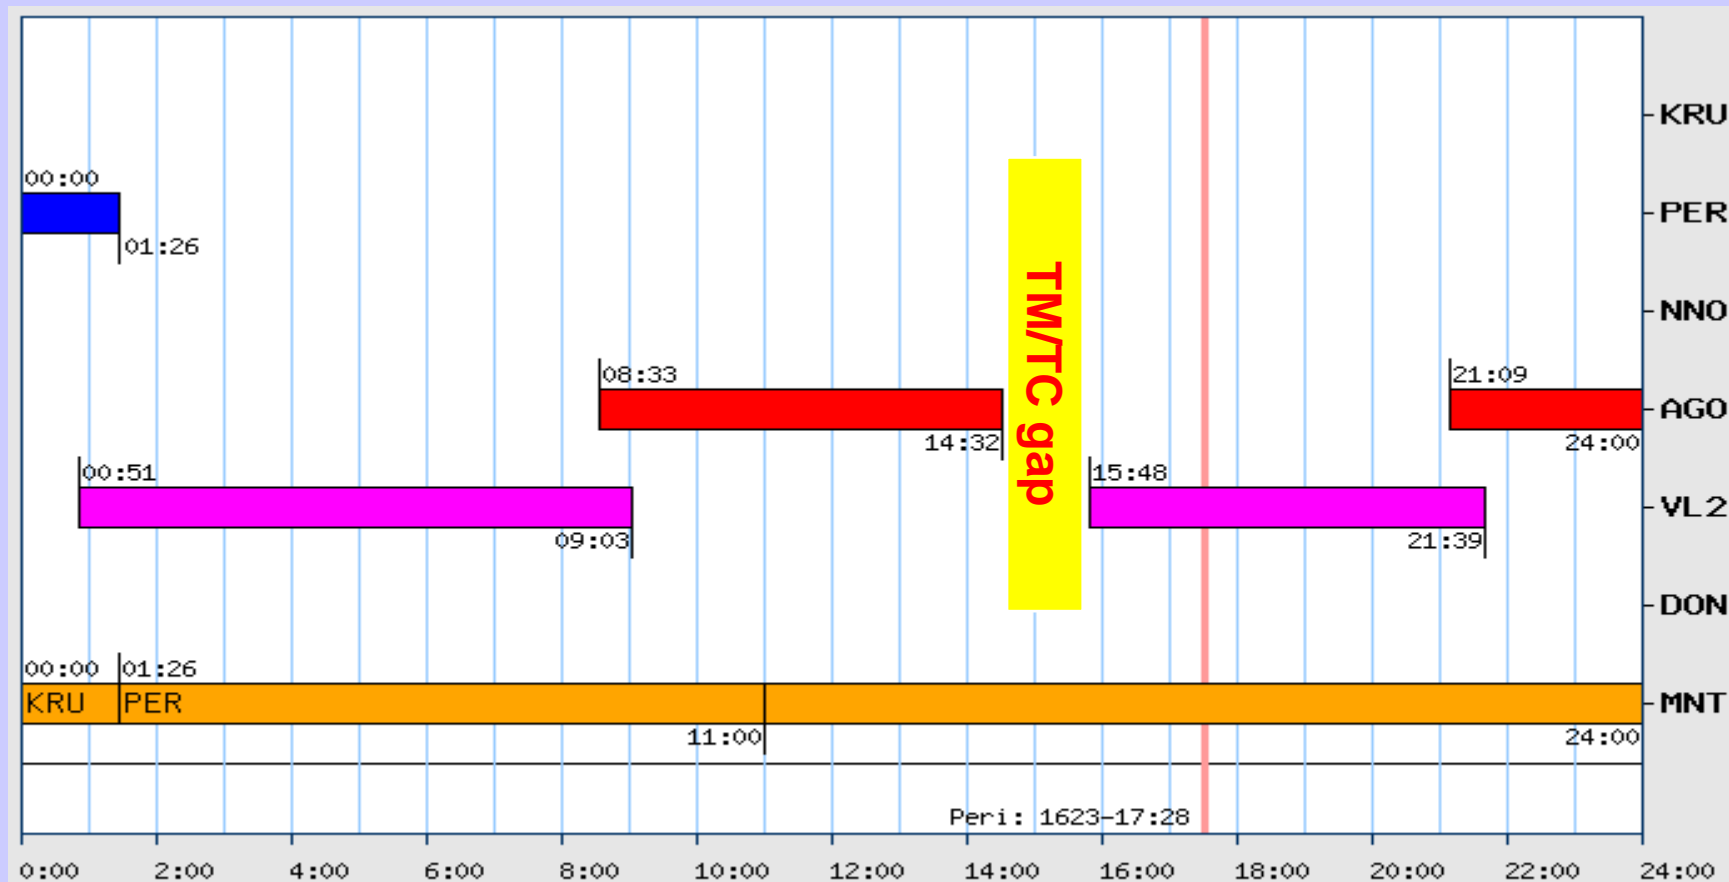
XMM-Newton Scheduled G/S coverage for DOY 292 (18/10/2008)

- 14.19: LOS Santiago
- 15.27: Time Tag Command RFDU SWA POS X
- 15.37: Expected AOS Villafranca → no signal

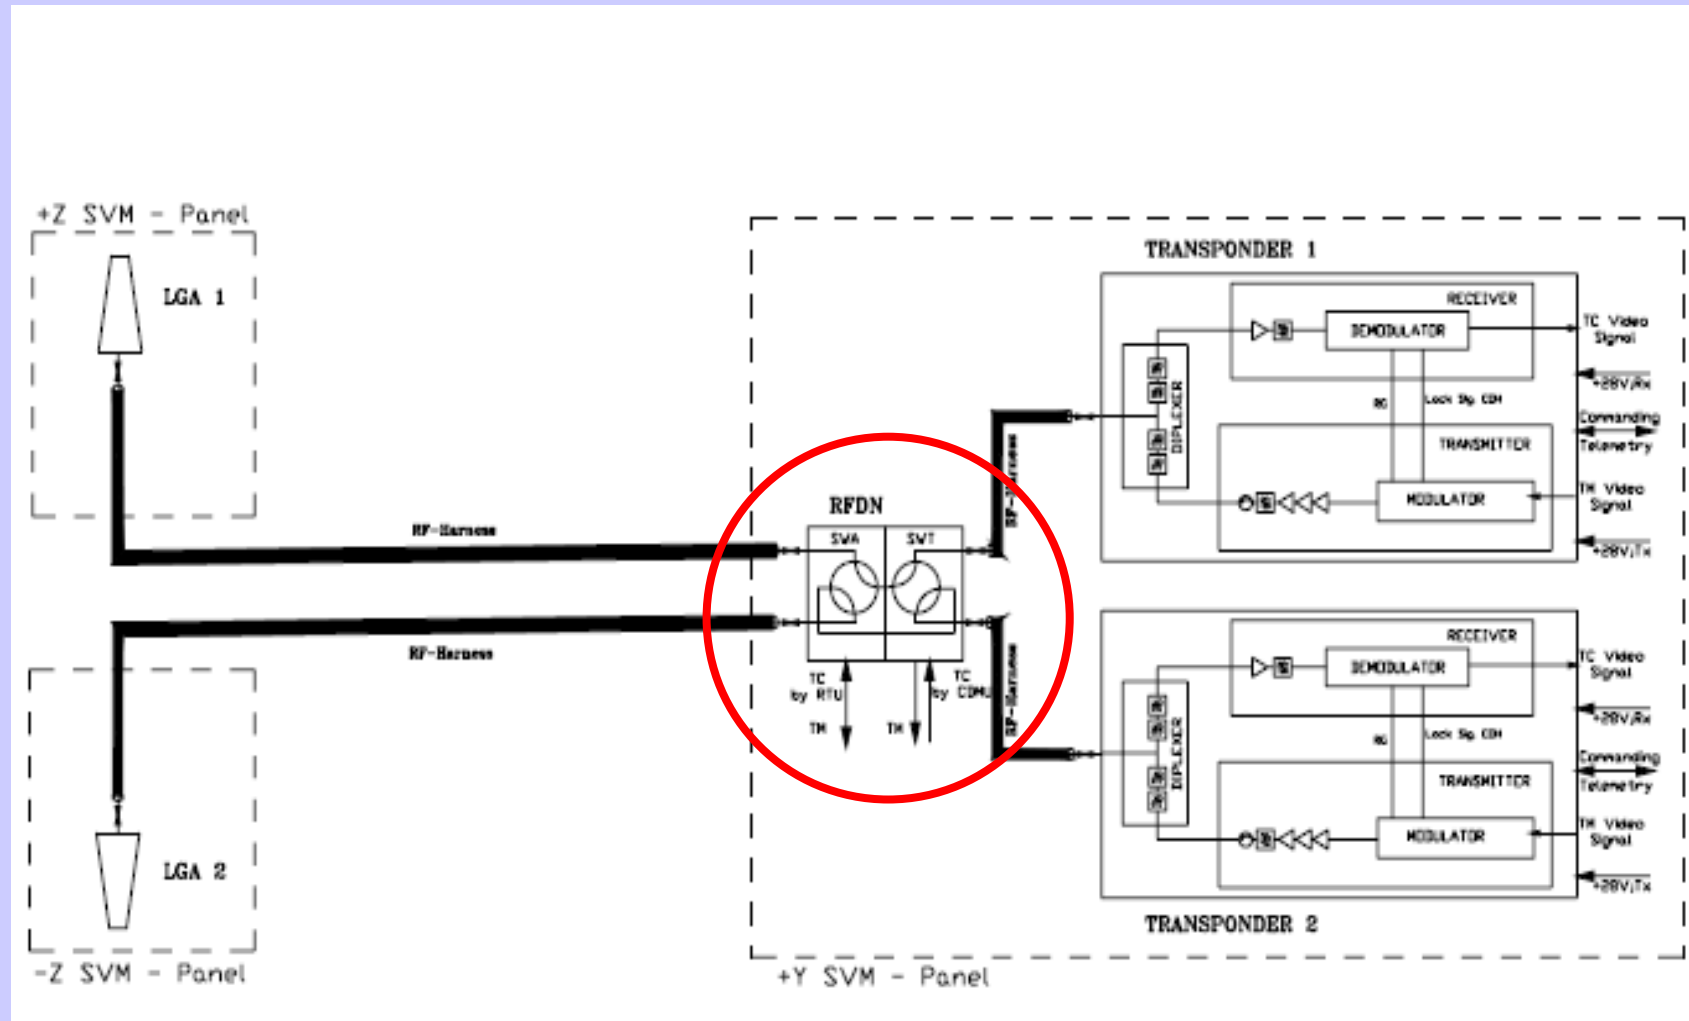
RF Switch

- **Failure of R/F Switch**
 - Considered possible
 - Linked to the last planned satellite operation
 - Considered as possible failure for INTEGRAL

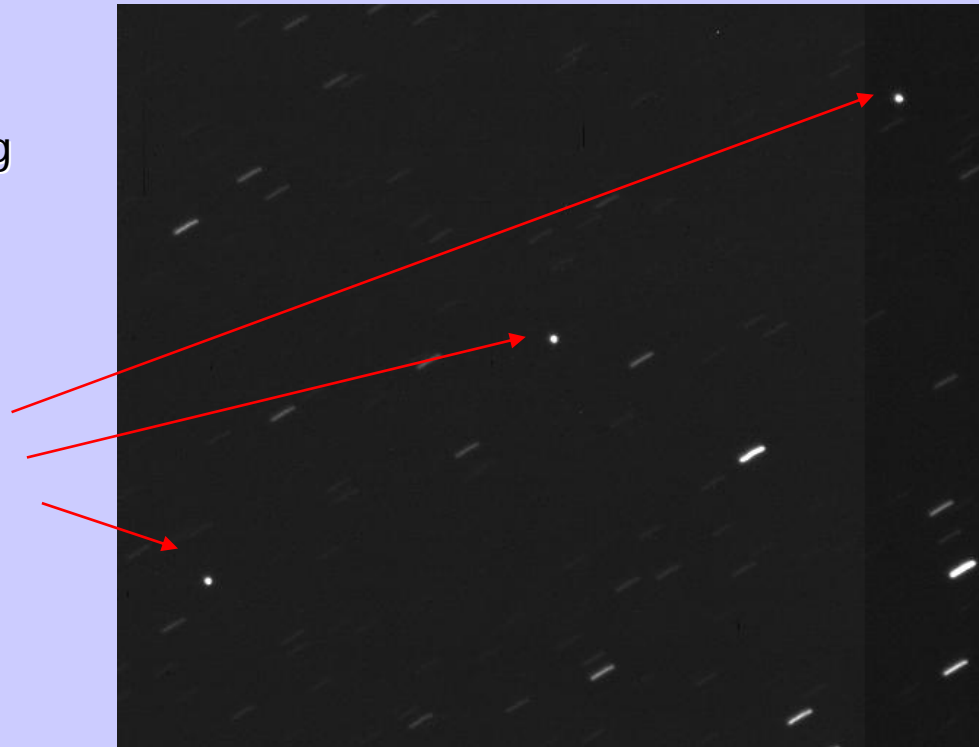
Optical data

- ESA Space Debris images re-confirmed that XMM was intact and no debris (> 10cm) was visible in its vicinity (150km)
- Astrometry is precise down to a level of a few arcsec
- Post-processing and determination of object states was done within 1 hour

- The telescope was tracking with XMM's angular velocity
- Three overlaid frames showing XMM as dots and stars as trails (2-second exposures)

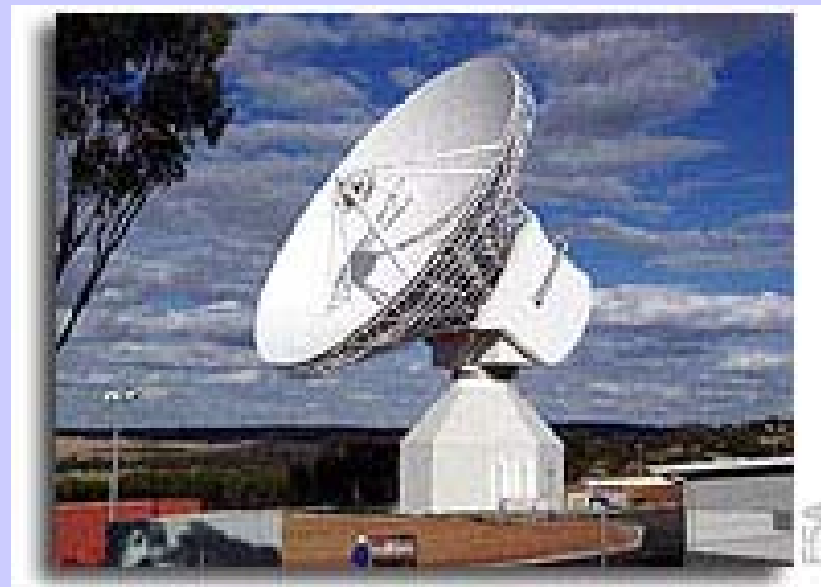
35m ESA New Norcia

- On 21 Oct a very weak signal was picked-up by ESA's 35-m antenna in New Norcia (West Australia) → Doppler information could be collected to confirm the orbit derived from the radar and optical tracking data
- Measurement of the signal attenuation (-55 db) indicating a failure of the switch → information concerning the required uplink power
- Commanding not possible via New Norcia, uplink power not sufficient
- Commanding not possible via Canberra, frequency not supported

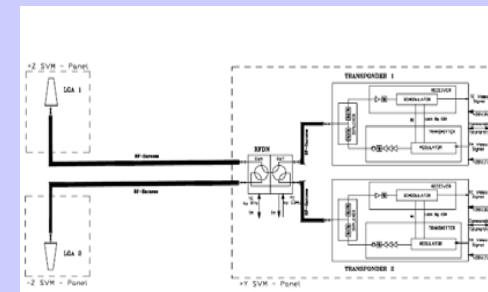
RF switch failure

- The Transfer Switches, that interconnect the transponders to the antennae, are of pulse latching type and operate in **break-before-make mode**.
- Each Transfer Switch will be capable of performing **minimum 50.000 switching cycles** and was tested to 10.000 hot switchings by INTEGRAL in October 1999 (same switch as XMM-Newton)

- Status Switch on 06-10-2008
 - **Total number of switchings: 3486**
 - Number of switchings left: 6514
- On 18 October, XMM-Newton failed to establish contact with the Villafranca 2 (Vil-2) ground station upon emerging from a nominal period of non-visibility between the Santiago ground station in Chile and Vil-2 in Spain.

- Reason: RF switch SW-A stuck in open position after Time-Tag command execution

Establish Operational Concept without the use of any RF switch

- use of only 1 transmitter
- use both transmitters permanently on or TX1 always on and TX2 on/off
- **alternate operations of transmitters TX1 on/TX2 off and TX1off/TX2 on**
