Realization of the Reflection Grating Spectrometer on XMM-Newton

The Reflection Grating Spectrometer (RGS)

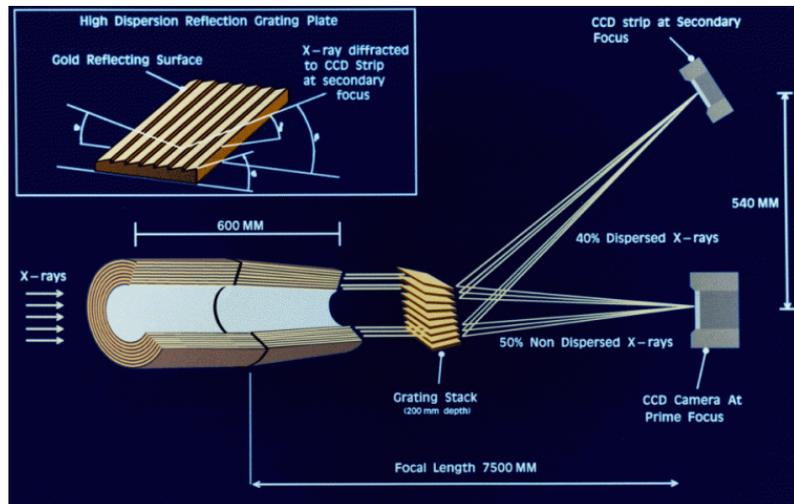
The basic diagram depicting the RGS instrument (of which there are two on XMM-Newton) is given at the right. Behind the X-ray collecting mirror a set of 182 gratings is placed which create a dispersed beam on a CCD strip at the secondary focus. Using the energy resolution of the CCDs the different orders can be separated. With this design a resolution varying between 100 and 500 has been realized.

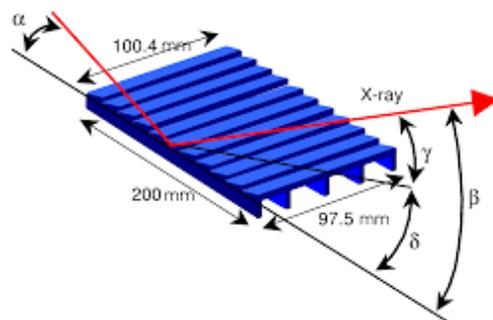
For the RGS instrument reflection gratings were selected as they allow to optimize the effective area with a good resolution in the energy band between 5-35 Å where K-shell transitions for low-Z elements (C, N, O, Ne, Si) and L-shell for Fe can be found. To achieve the effective area one needs to match the full exit aperture of the mirrors and this requires a large set of ultra-flat, accurate and light-weight gratings. This was feasible by placing 182, accurately flat gratings of 100 x 200 mm² in the convergent beam of the telescope. Many issues had to be overcome (our US colleagues had the lead) but to mention some:

- A variable line density was required. To get this right at the master grating an interferometrically controlled ruling machine was used
- All gratings had to be identical requiring a very repeatable process using one master grating and making replicas from this

- The gratings had to be very stiff and thin. SiC was selected as substrate and ribs were applied to enable the correct surface flatness
- Scattering from the back sides of the gratings and from the ribs had to be taken into account and to be minimized (by having a rough surface)

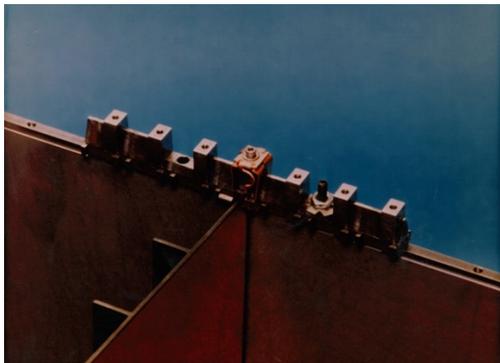
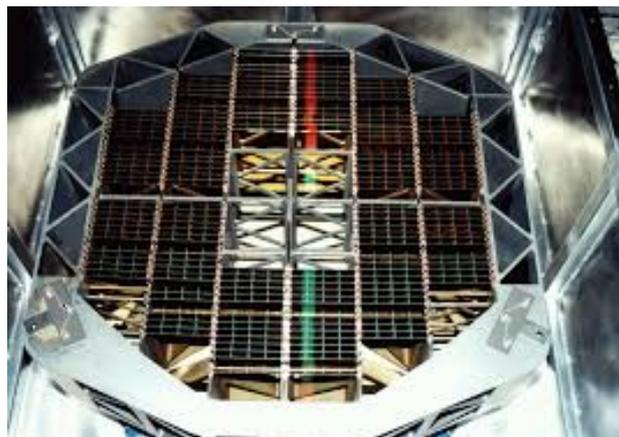
Alignment rails for the gratings (left) and an integrated Reflection grating Assembly with 182 gratings (right)

- The gratings needed to be mounted in a light weight structure with a very low thermal expansion (to maintain the alignment between the 182 gratings). A Beryllium structure was selected but manufacturing of such a large structure was a real challenge. Only two proto-flight units were produced

- Each grating had to be accurately positioned in the grating structure. This was done in a two-step approach: 4 rails which could fix 8 gratings were accurately glued to the Be-structure and next the gratings were hold in place by clips (see figure). However, during vibration tests these clips started to resonate and a soft glue had to be added to avoid this. One of these rails had a production error and the position was left open (explaining the difference of 182 – 181 gratings per grating box)

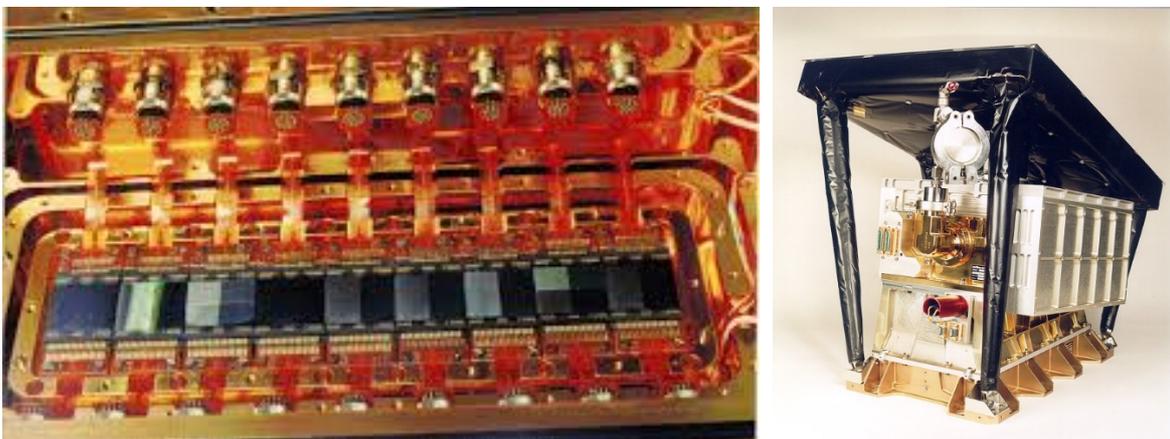
The CCD bench is shown below where 9 CCDs are placed on the Rowland circle with a minimal gap between them. Vacuum feedthroughs are also visible to allow the camera to stay closed on the ground. At the right side the integrated camera is shown with its radiator (to enable passive cooling to -120°C). The temperature is controlled by heaters on the CCD bench. Also seen is a part of the ground support equipment to enable the purging of the camera with dry Nitrogen.

The CCD bench with 9 frame transfer CCDs and the integrated camera clearly showing the passive radiator

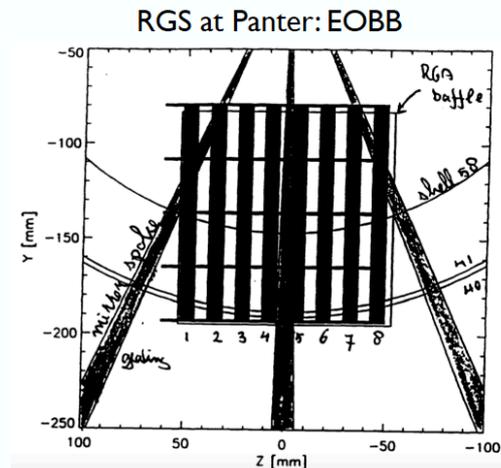
The calibrations and verifications were performed very early in the development cycle. Early testing of a system is always a very beneficial exercise. Any problem found early can be relatively cheaply solved. For RGS we performed an early test in the so-called Electro-Optical Breadboard (EOB) where we combined a set of 8 properly aligned gratings with a model of the mirror with 4 shells in place. Due to the relative orientation of the optical layout, the resolution is much better than for a fully populated RGS ($R \sim 3000$). At the right we show this layout as seen from the camera.

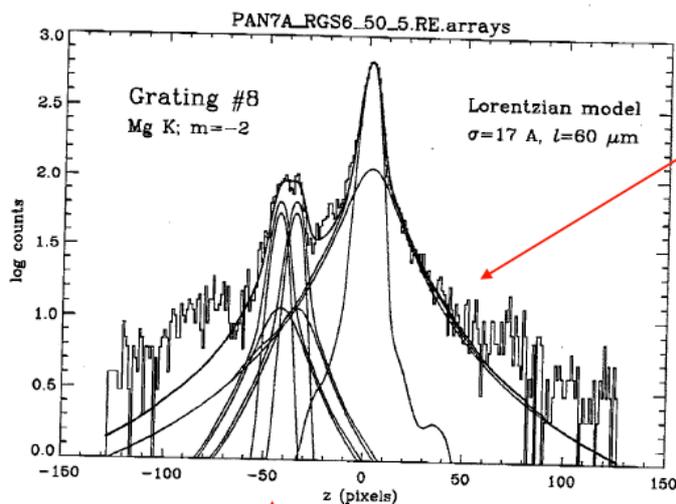
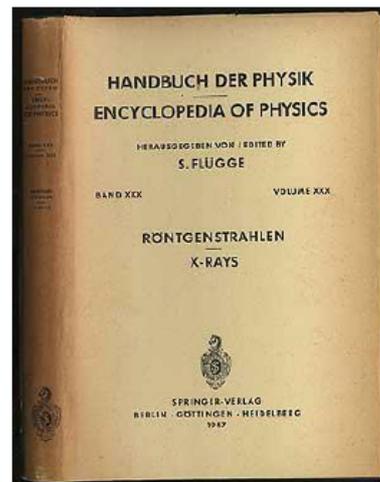
To our surprise, the width of the emission lines (the resolution) measured in the EOB was not as we expected. At shorter wavelength a second peak appeared which we could not explain. Where these reflections from the ribs which support each grating or could this be a kink in the grating surface? Colleague Heinrich Bräuninger alerted us to satellite lines listed in the *Handbuch der Physik* (1957) indicating that satellite lines will appear at longer wavelength than their 'parent line' in highly ionized plasmas. With new instrumentation we do not only push the limits of our knowledge about astrophysical sources but one can expect also to push the limits of the experimental setup at the ground facilities. A similar situation occurred when we placed our grating box in an apparently non-divergent UV beam in the Liège test facility and after a tedious effort we could conclude that there was a small divergence in the beam (less than 1 arcsec).

A measured line spread function for the EOBB at the Panter facility and the Handbuch de physic in which this effect is described

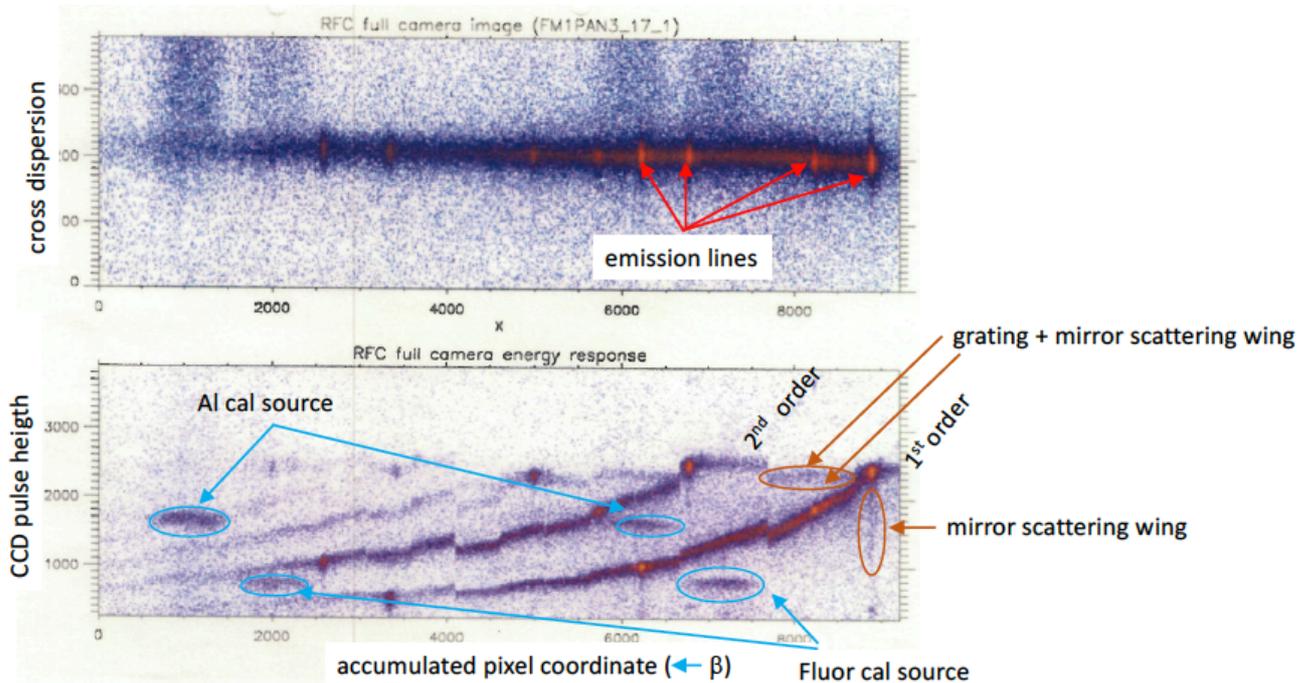
All these aspects had to be included in the calibrations of the instrument and having some data looking flight-like before the launch allows verification of the pipeline processing in a relatively early stage. Whereas our calibrations were concentrated on single, narrow, emission lines as this enabled us to determine efficiencies as well, at the end of the calibration campaigns we used a continuum source where clearly the lines and the bremsstrahlung is visible. We show this below.

A continuum spectrum using an Au target collected during the calibration campaign in August 1997

As one of the last steps during the calibrations at Panter we have used a Au source with multiple lines and the results look similar to what one can expect for flight data. These measurements were performed in August 1997, more than two years before launch. For illustration we show the raw, uncorrected data as this nicely displays a number of key features. At the top panel of the figure below the Image for the source is shown (vertical cross dispersion, horizontal the dispersion in terms of accumulated pixel coordinates). At the bottom panel the corresponding CCD spectra are shown. Clearly the ‘banana-like’ representations follow the dispersion equation (note that contrary to the usual representation where the scattering angle increases to the right, in this case the scattering angle decreases to the right).

We can identify a number of components which are all taken into account in the data processing:

- In this raw data clearly the effect of the gain per CCD-half is visible (step function in the vertical direction between the different CCDs)
- the scattering wings of the mirrors is shown by the vertical extension of the spots near bright emission lines

- The combined scattering wings from the gratings and the mirror in the horizontal direction. Already this raw data shows that the gratings have a significant contribution to the scattering

- Two sets of 2 calibration sources which are mounted inside the camera and consist of an Am²⁴⁴ source (alpha emitter with a Teflon or Al target). The purpose was to use these sources as energy calibrator (which indeed works as expected) and as contamination monitor (monitoring the relative changes in the ratio of the F/Al lines as function of time). The latter function turned out to be more complex as one needs to include also the contamination on top of the Am source itself (e.g. an ice layer stops very efficiently the alpha particles) creating an additional free parameter

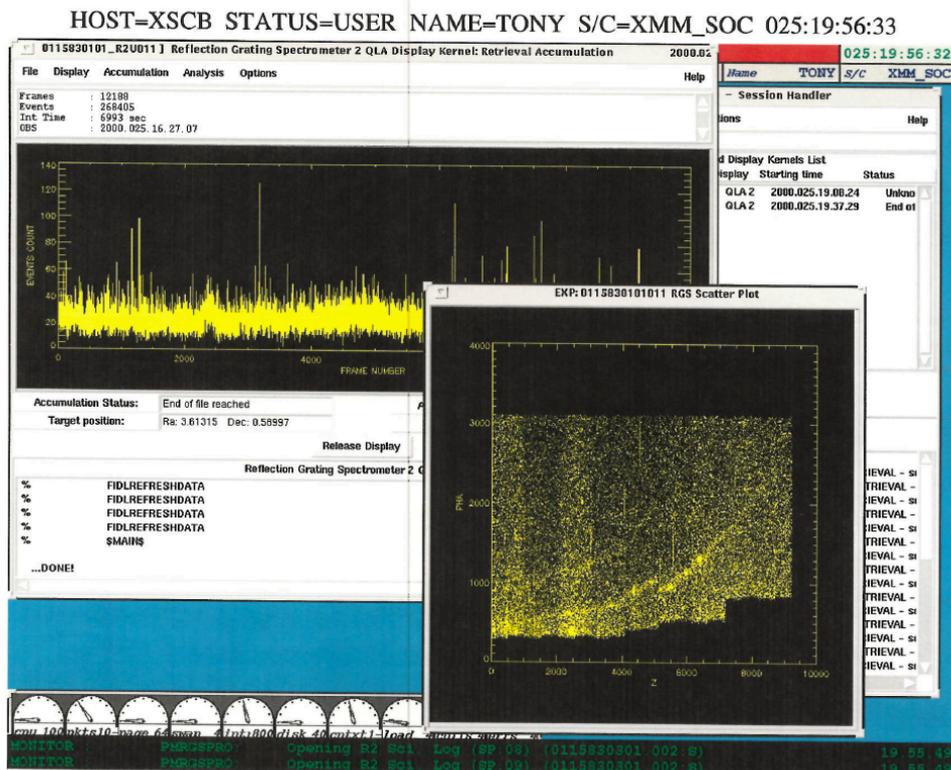
Of course, the next step was to see if X-rays were detected. In this phase the ESAC Quick Look facility could almost immediately process the data. This is shown below where it is clearly seen that these data are completely uncalibrated (e.g. the 9 CCDs with their own gain are visible). Nevertheless the 'banana like' plot was seen including the intensity variations corresponding to emission lines in HR1099.

First data with the Quick Look Analysis at ESAC

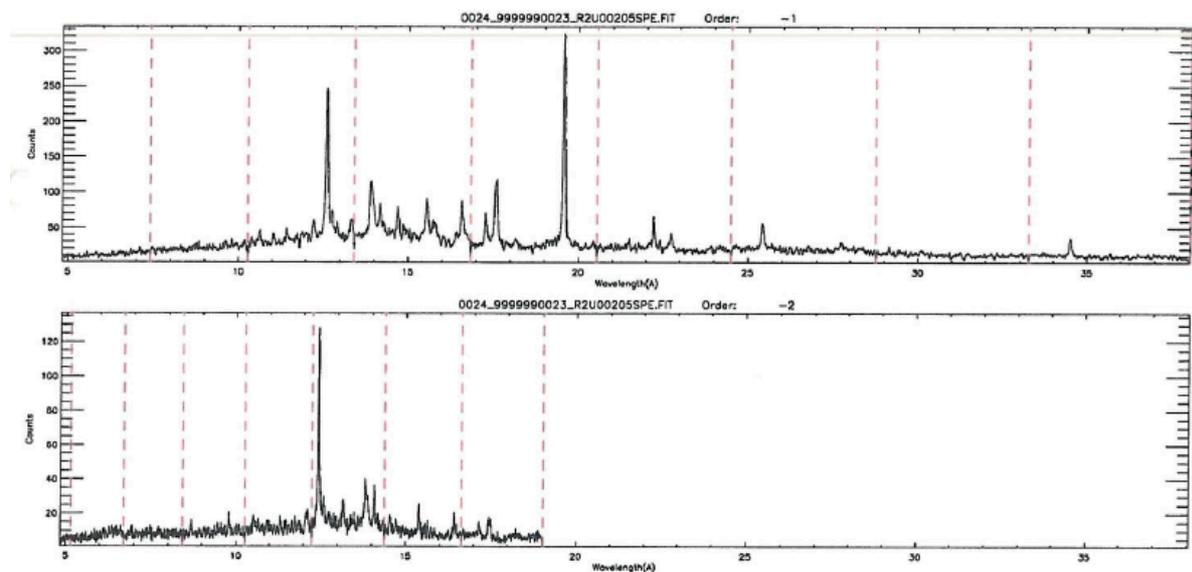
First full spectrum of HR1099 2 days after the data were taken is shown below.

First HR1099 spectrum observed with RGS2

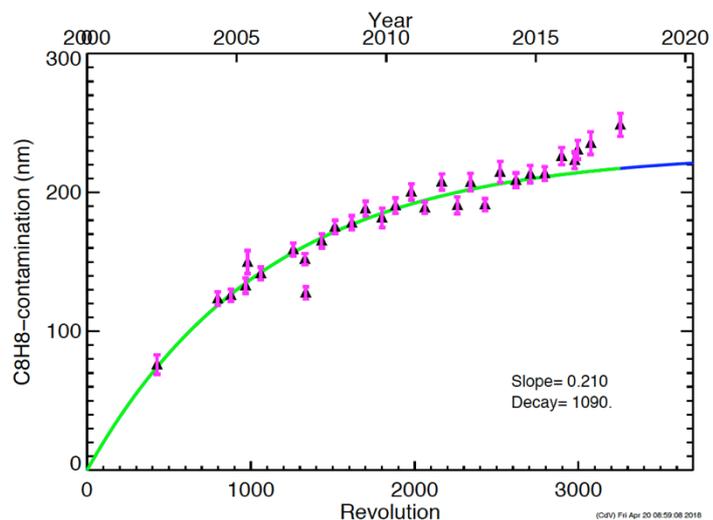
There has been a gradual increase in the collection of hydro-carbons on our cooled detectors. The evolution over time is globally as expected but there are some unexplained changes (e.g. the deviation after orbit 3000) for which no physical realistic cause could be found (such as a change in the CCD redistribution function or an additional contamination component). To some degree this has been observed for more parameters: the relative changes

in the effective area between RGS1 and RGS2 differ slightly more than we can easily justify. However, in all these cases the data tell you what the truth is and you better update your instrument models to match reality and not to match your physical understanding.

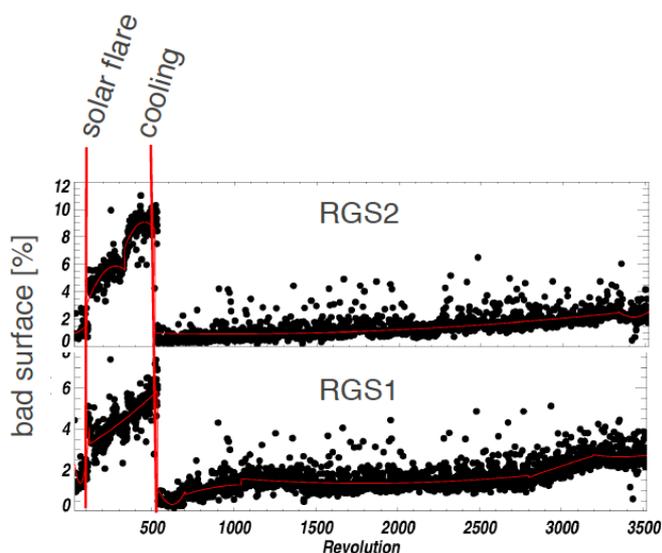
Another example is the fraction of bad surface of the CCDs caused by lattice displacement in the CCD due to charged particle hits. It was known that it increases as function of time due to radiation damage (and strong solar flares such as the one early in orbit will accelerate this). At the same time we knew that cooling from -80°C to -110°C would reduce the impact of this damage dramatically. Having reached a level of $\sim 2\%$ of the area after 20 years tells us that we can handle this far beyond the potential operational life time. Detailed analysis also shows that not all damage is persistent, after a period some of the damage will disappear.

Detailed analysis also shows that not all damage is persistent, after a period some of the damage will disappear.
