XMM recoveries in 2008

the new operations strategy re. antennae switching

Dr. Marcus G. F. Kirsch
XMM-Newton Deputy Spacecraft Operations Manager

European Space Agency (ESA)
European Space Operations Centre (ESOC)

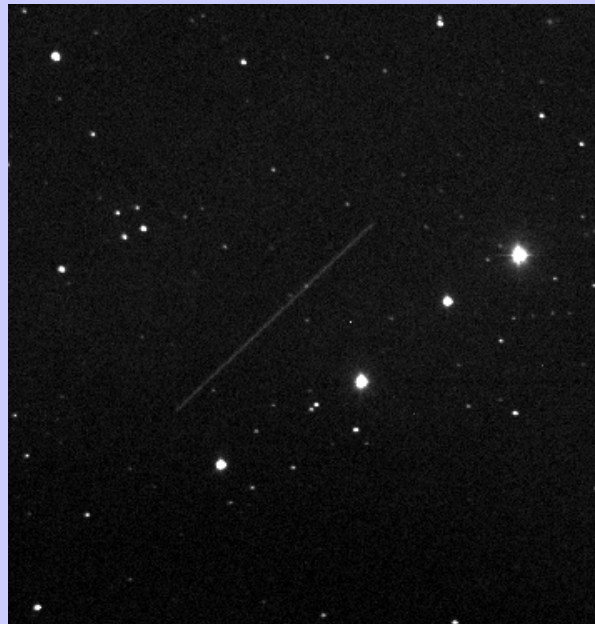
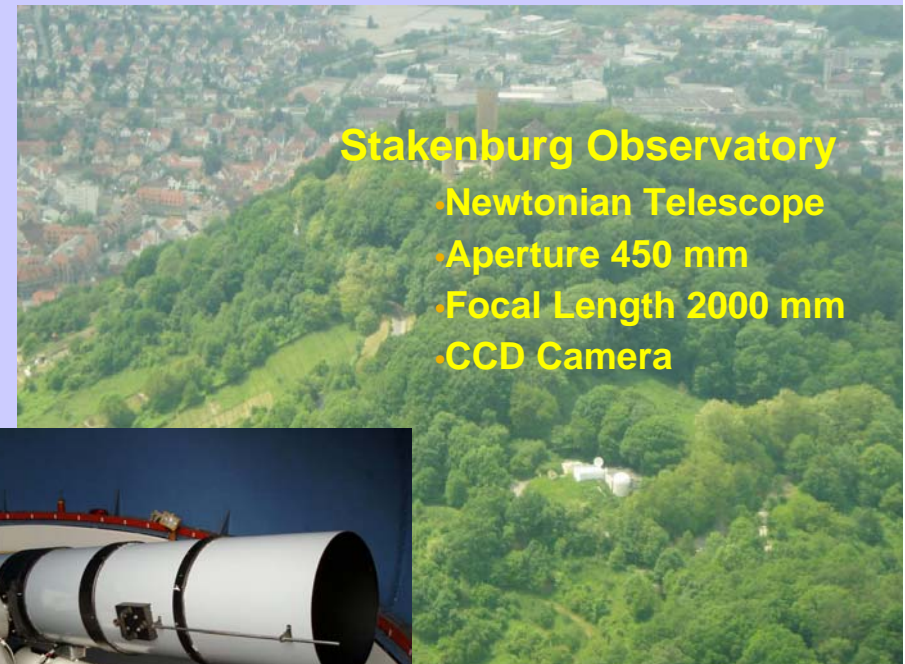
- October 20th: amateur astronomers at Stakenburg observatory imaged track of XMM-Newton. Observations were also performed by two other telescopes, German radar and US Space Command → No catastrophic event such as an explosion, thruster malfunction, or collision with space debris or a meteorite.

- Satellite on predicted path
- No visible debris
- No indication of light fluctuation caused by S/C spin

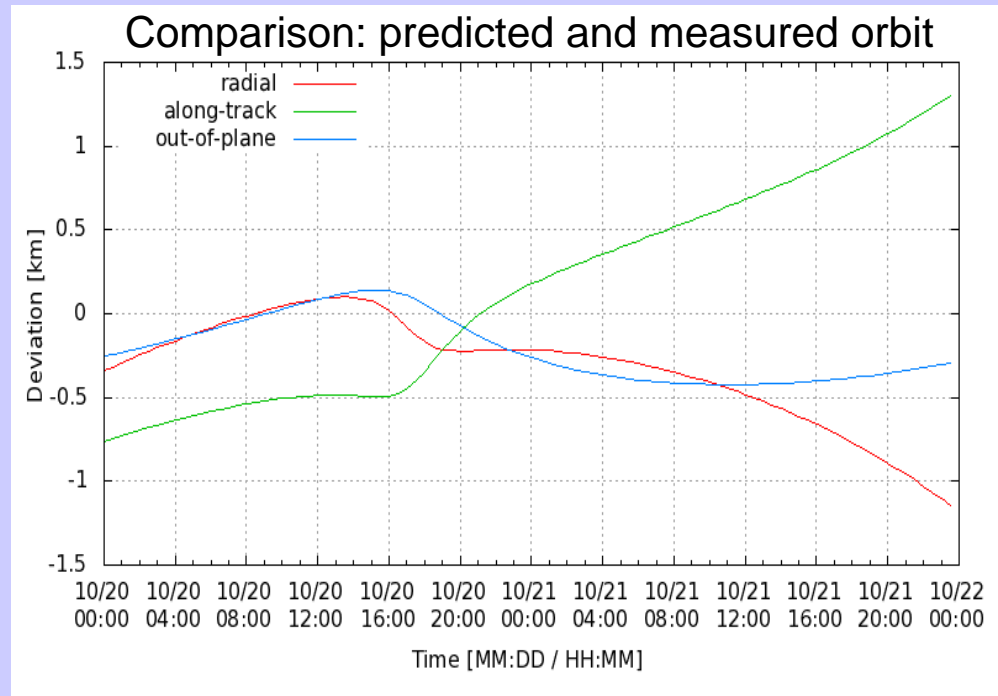
- Although observation data only covered a period of 4 hours after perigee passage, it was sufficient to determine an accurate orbit
- Orbit determination was independent from any operational data
- Orbit determination accuracy was sufficient to clarify that the orbit was nominal (matched the predicted one within 1km RMS)

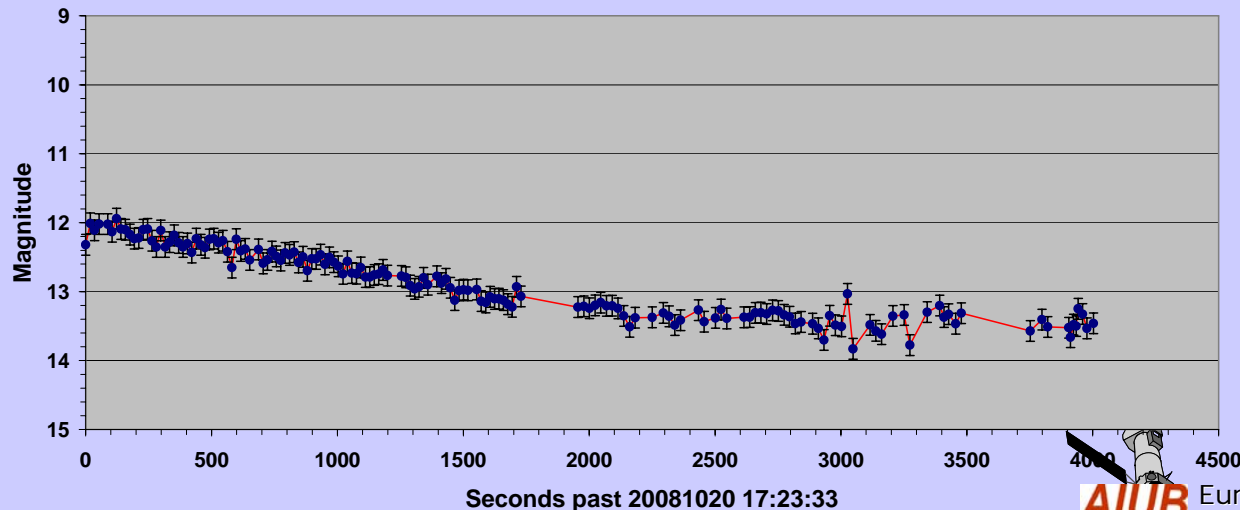
Light Curve 99066A

- Despite of the enormous range, FGAN was able to generate 1.5 hours of tracking data
- Fusion of data from optical telescopes and radar was performed for the very first time in ESA
- While weather conditions on Tenerife allowed only 20 minutes of observation, the Zimmerwald telescopes were able to observe for about 1 hour
- High frequent magnitude variations were not observed revealing that the attitude was nominal
